Case Study 1: Full Zirconia Denture Bridge

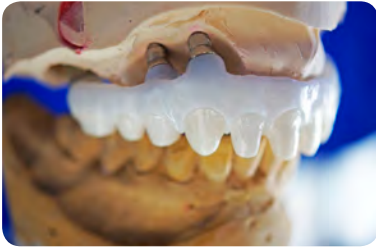
After an initial wax try-in to establish vertical dimension, lip support, and aesthetics, zirconia framework was fabricated as the base of the restoration. Upon completion of the zirconia frame, it was sent to the doctor for a frame try-in to verify the fit. Next, 12 individual lava coping were fabricated to be fixed to the zirconia framework.

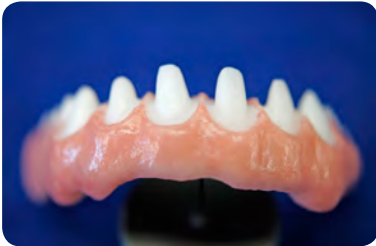
Next, individual Lava crowns were built and pink porcelain was added to recreate the gingiva.

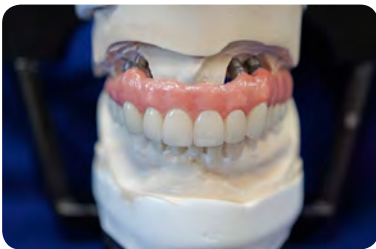
Finalized crowns are then cemented to the zirconia framework resulting in a highly aesthetic alternative to dentures.

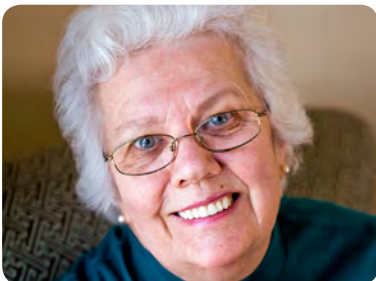
The final Restoration has been delivered and the patient is now able to enjoy her new smile.

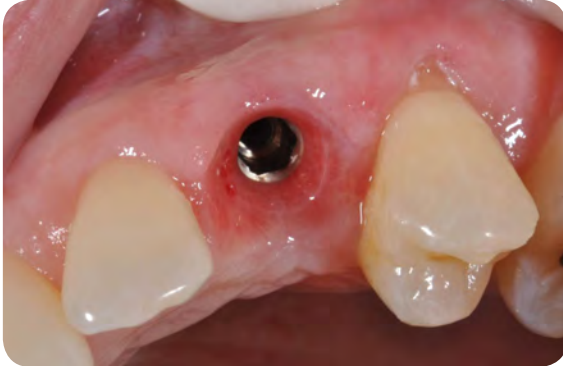
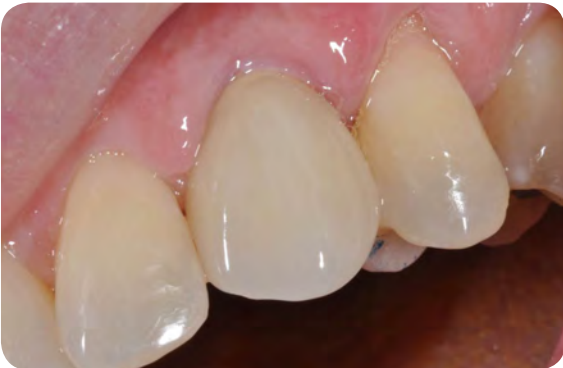
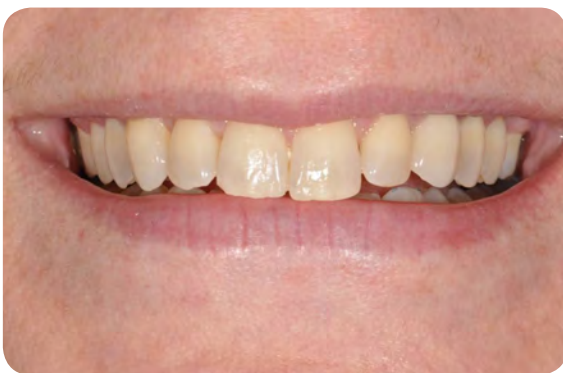
Case Study 2: Lava Crown Implant

“At times the most difficult cases can appear to be incredibly simple. With that in mind, many in the restorative field know the difficulties that can arise when creating single anterior crown over an implant with natural adjacent dentition. That is why we were pleased with the outcome of this single Lava crown fixed over an implant.”

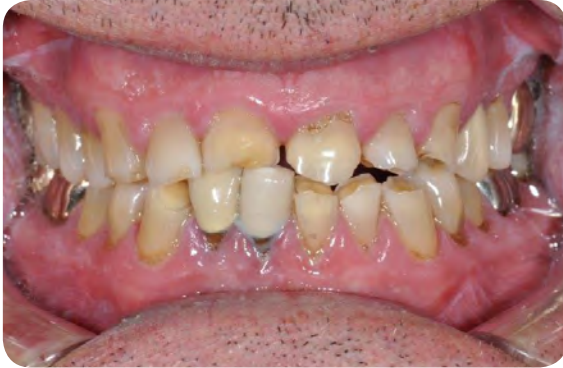
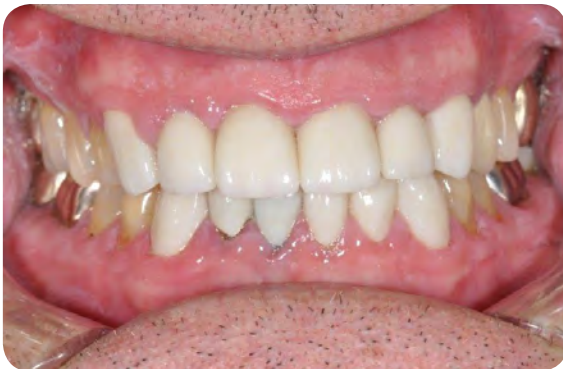
Case Study 3: Twelve-Unit BruxZir

“This patient was seeing extreme wear on nearly all of the existing dentition. A marriage of aesthetics and strength was necessary for these 12 anterior restorations. 12 BruxZir (monolithic zirconia) crowns helped us achieve exactly what the patient and doctor were looking for.”
